MORRISON HERSHFIELD

August 25, 2022

**Re: Structural Assessment – Hot Tub Support Framing**

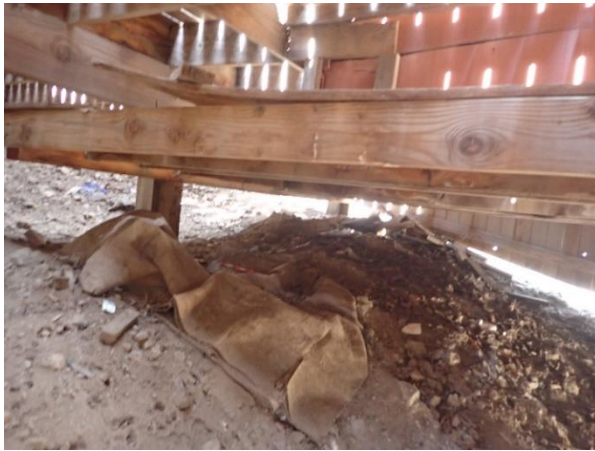
Framing for the original construction varied by location, but mainly consisted of 2x joists running perpendicular to the decking above. The joists were attached with nails or connectors to a 2x or 4x beam that rested on 4x posts. The posts were set into the ground onto a small concrete foundation or on a precast concrete block. On top of the joists was typically a piece of wood sheathing, such as plywood or OSB. See Figures 1 and 2 for typical arrangements.

*Figure 1 – Typical Original Framing*

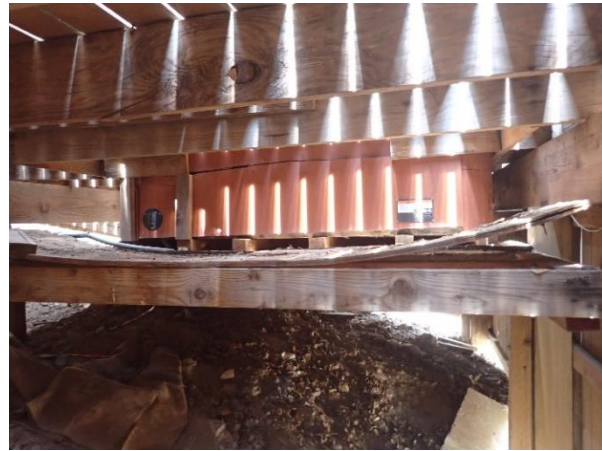
*Figure 2 – Typical Original Framing and Sheathing*

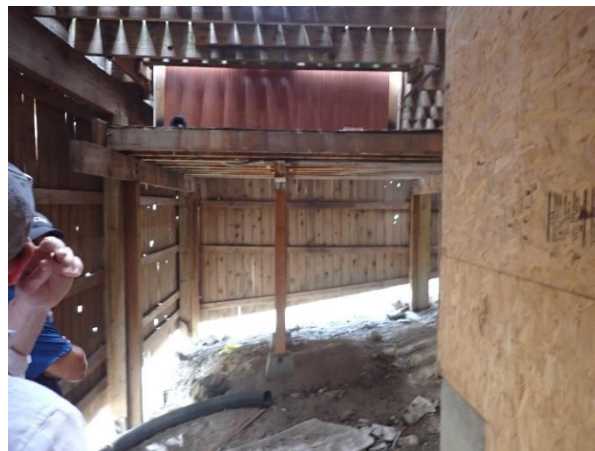
In all observed cases, there was no lateral system, such as a sheathing-encased wall or diagonal braces. While the framing in some cases attached to the outer skirting of the decks, the siding of the decks was not designed to resist lateral loads and does not have the capacity or detailing to resist such loads. See Figure 3 for an example of a hot tub framing connected to the outer siding.

*Figure 3 – No Lateral Bracing*

Our recommendations for the hot tub supports are based on our observations and upon our recommendations for the structural framing of the decking (see MH's letter regarding decking condition assessment). It is our opinion that the original hot tub support framing is at the end of its useful service life and that all the hot tub supports should be replaced right away as part of the complete deck replacement recommendations in our letter regarding the condition of the decks. In our opinion, it is impractical to repair, or retrofit, the inadequate hot tub support framing independent of replacing the deck framing for both the recessed and "on top" hot tub conditions, given the many structural concerns with the original design, the condition of the deck framing and hot tub support framing, and the recently installed inadequate hot tub support repairs. We recommend that the new deck and hot tub support framing be designed by a structural engineer, licensed in the State of Oregon, and that the design include an analysis of code required wind and seismic loading, and that the design include the necessary detailing for an adequate lateral load resisting system, such as diagonal bracing or shear panels. This recommendation applies to all the hot tub supports at the property, regardless of location (river side versus golf course side).

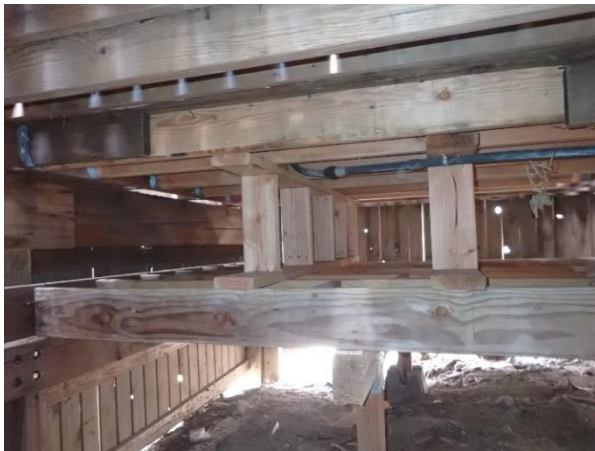
For framing hot tub support with the hot tub located on top of the decks, the framing mainly consisted of filling in the existing inset space with decking matching the size of the current composite (Trex®) decking. Beneath the hot tubs was a combination of unsheathed and unbraced 2x cripple walls supporting new 2x joists. The cripple wall was placed on top of the original elevated platform. In some cases, the joists were attached to an end beam that was inadequately supported by a single floor joist. In some cases, new posts had been placed in the center of the hot tub area resting on pre-cast concrete blocks. The connection hardware and wood for these renovations appeared to be in good condition and showed no signs of damage or defect, but stacking unbraced framing on top of unbraced framing is a stability concern. See Figures 4 through 7 for examples.

*Figure 4 – Typical Unbraced Renovation Framing*

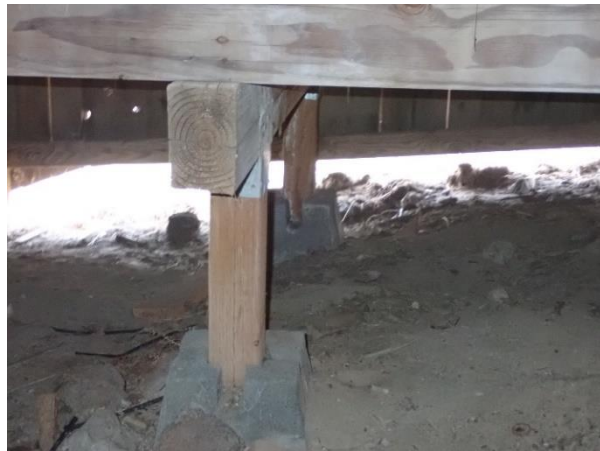
*Figure 5 – Typical Renovation Post*

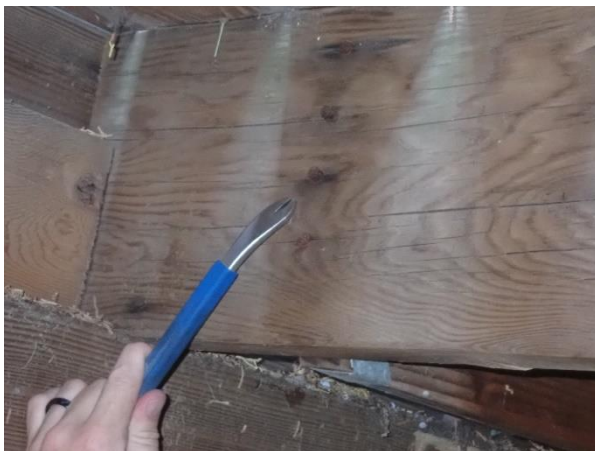
*Figure 6 – Inadequate Support of New Framing*

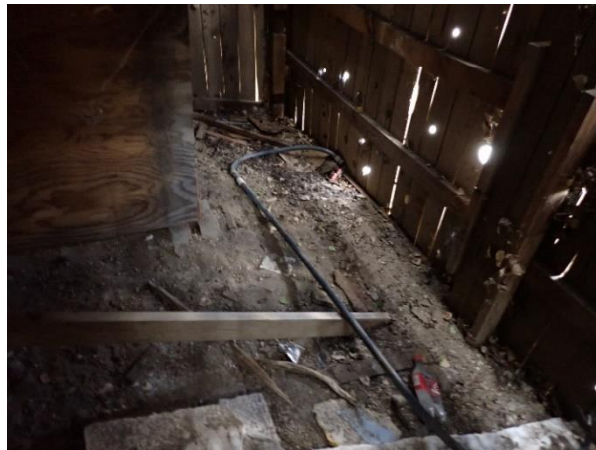
At one location (Unit 7), there was an additional sheathed wall underneath the elevated platform and diagonal bracing from the platform level to the ground; presumably to provide some makeshift lateral bracing. However, the braces were not properly embedded or attached to a foundation and appeared to be inadequate. Additionally, Paul Fujimoto stated that the sheathing and braces had been added since the issue of framing adequacy had been raised by the Board, and showed pictures dated several weeks prior that verified that the bracing had only recently been installed. See Figure 8 for the bracing noted.

*Figure 8 – Bracing and Sheathed Wall*
