August 25, 2022

River View Vista Estates  
Eagle Crest Management  
c/o Marrison Rainey  
PO Box 1215  
Redmond, OR 97755

**Re: Structural Assessment – Decks and Deck Framing**

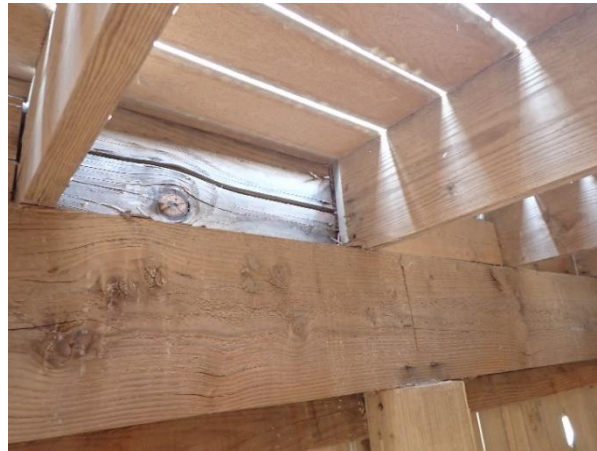
There was no seismic bracing provided, and the skirting at the edge of the deck was not properly detailed to be an adequate shear wall, and so there is not an adequate lateral load resisting system present in either direction (parallel or perpendicular to the units). See Figure 1 for typical framing arrangement.

*Figure 1 – Typical Framing Arrangement*

It is our opinion that the deck structural framing is at the end of its useful service life and should be replaced throughout the property right away. We recommend that the new decks be designed by a structural engineer, licensed in the State of Oregon, and that the design include an analysis of code required wind and seismic loading, and that the design include the necessary detailing for an adequate lateral load resisting system, such as diagonal bracing or shear panels. Our recommendation applies to all the decks at the property, regardless of location (river side versus golf course side), or contents of the deck (hot tubs versus no hot tubs). Further discussion on the structural assessment of the hot tubs is addressed in a separate letter from MH.

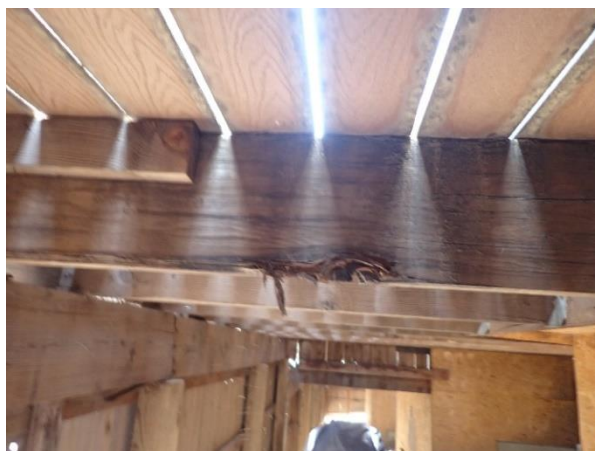
In approximately 15% to 20% of structural framing members observed there were signs of decay, damage, defect or deterioration, which compromised the structural performance of the members. Figures 2 through 5 show examples of the structural deteriorations observed.

*Figure 2 – Damaged Joist*

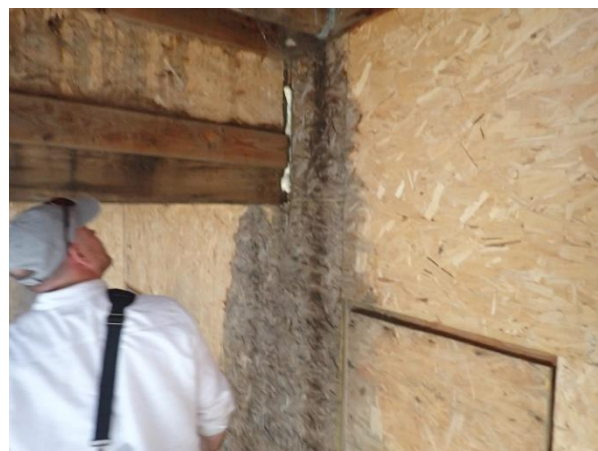
*Figure 3 – Moisture Damage to Paneling and Connection*

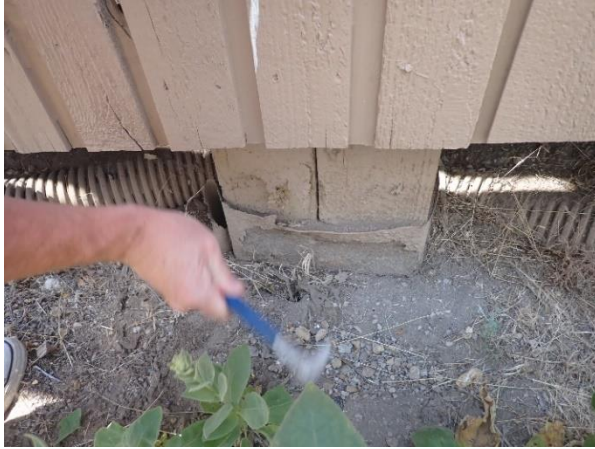
*Figure 4 – Decaying Post at Base*

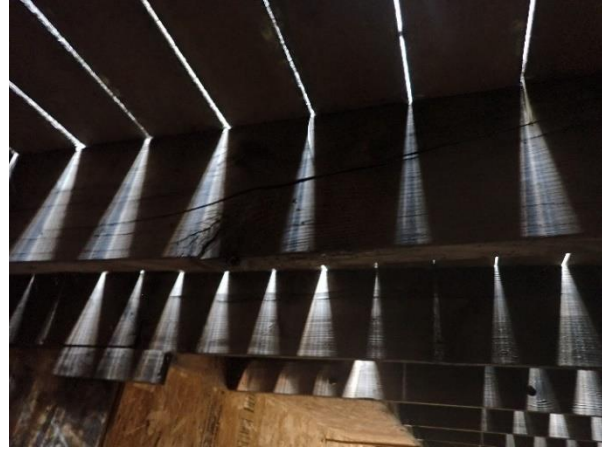
*Figure 5 – Split Joist*

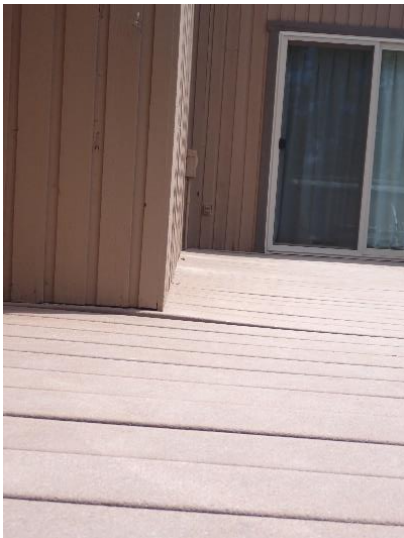
The composite decking was noted to be excessively deformed in several locations, showing signs of settlement, warping or excessive displacement when walked upon. See Figures 6 and 7 for examples of decking failures.

*Figure 6 – Deck Warping at Exterior Wall*

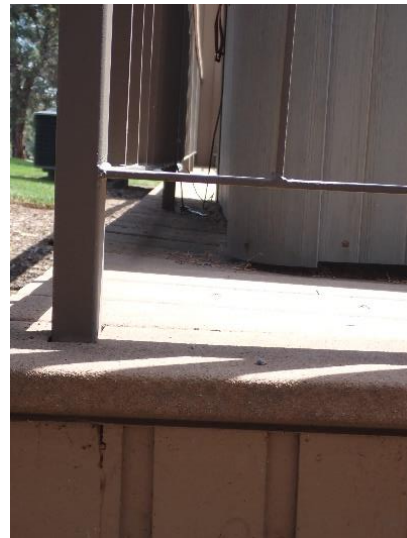
*Figure 7 – Deck Warping at Hot tub*
